DEPARTMENT OF TRANSPORTATION

Quality Assurance and Source Inspection

Contract #: 04-0120F4Cty: SF/ALA Rte: 80 PM: 13.2/13.9File #: 1.28**WELDING INSPECTION REPORT****Resident Engineer:** Casey, William**Address:** 333 Burma Road**City:** Oakland, CA 94607**Report No:** WIR-029688**Date Inspected:** 14-May-2013**Project Name:** SAS Superstructure**OSM Arrival Time:** 1230**Prime Contractor:** American Bridge/Fluor Enterprises, a JV**OSM Departure Time:** 1730**Contractor:** American Bridge/Fluor Enterprises, a JV**Location:** Job Site**CWI Name:** As noted below**CWI Present:** Yes No**Inspected CWI report:** Yes No N/A**Rod Oven in Use:** Yes No N/A**Electrode to specification:** Yes No N/A**Weld Procedures Followed:** Yes No N/A**Qualified Welders:** Yes No N/A**Verified Joint Fit-up:** Yes No N/A**Approved Drawings:** Yes No N/A**Approved WPS:** Yes No N/A**Delayed / Cancelled:** Yes No N/A**Bridge No:** 34-0006**Component:** SAS Tower**Summary of Items Observed:**

WELDING INSPECTION REPORT

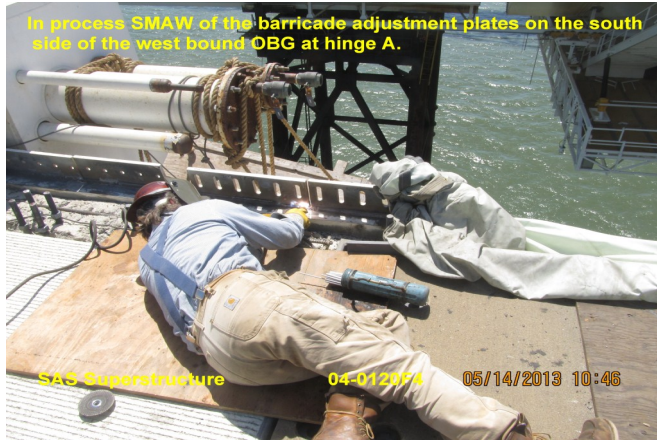
This QA Inspector randomly observed ABF welder Eric Sparks #3040 perform the Shielded Metal Arc Welding (SMAW) process on the Hinge A barricade adjustment plates 5-8 (PL5, PL6, PL7 and PL8) on the south side of the westbound OBG. The welder was observed utilizing WPS ABF-D1.5-1072-Revision 1 for Complete Joint Penetration (CJP) welding. The welder was observed preheating the surface area prior to welding and other welding parameters as inspected by the QC Inspector were recorded as 136 amperes and appeared to be in compliance with the WPS noted above. The QA Inspector made subsequent observations throughout the shift to monitor quality and noted that the work was in progress and appeared to be in general conformance with the contract documents.
